Characterization of Kalamazoo Lake and Harbor Hydrology to Support Recreational Boating

Final Report December 2022

MDNR Michigan Waterways Grant Program Allegan County Contract # 11046

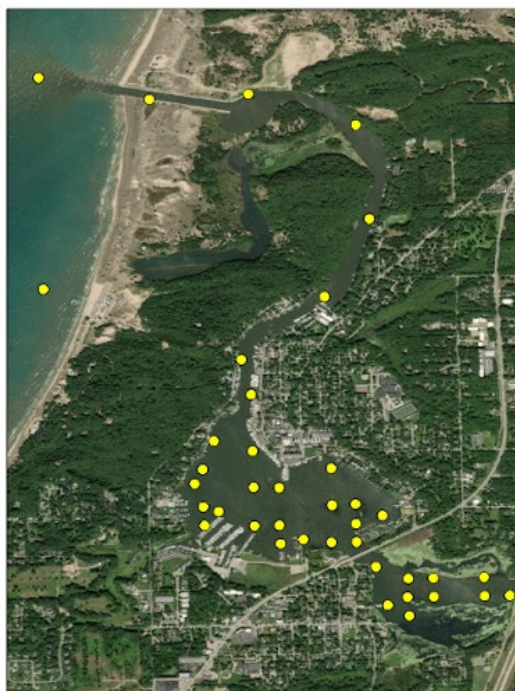
Figure 1: Locations of sediment sampling sites for 2019 effort.

The 2019 sediment sampling effort included sediment cores from 39 sites. To facilitate comparisons to historic retrievals, sampling points were selected to overlap past sampling sites, primarily those from the 2000 effort. Site locations were in Kalamazoo Lake, the adjoining river channels, and two sites in Lake Michigan (Figure 1).

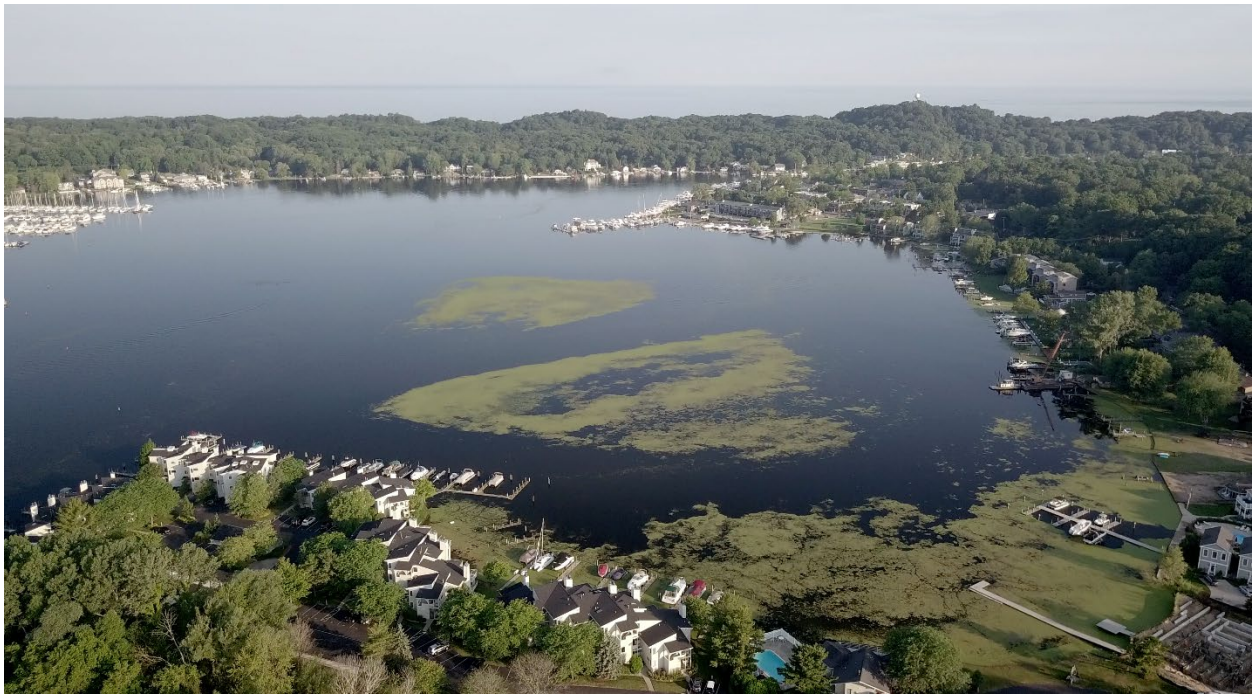
Figure 9: Still photo extracted from a drone video taken on July 8, 2020 over Kalamazoo Lake. The photo shows the large patches of Eurasian watermilfoil growing in the eastern basin of Kalamazoo Lake between the East Shore Harbor Condominiums and Sergeant Marina.

On two separate dates in 2020 and 2021, an FAA-certified MTRI scientist collected drone footage around the Kalamazoo Lake region, including Kalamazoo Lake and the adjoining river channels. This page includes 7 high resolution videos resulting from these drone flights. Of note, these videos show the high concentrations of emergent vegetation in 2020, and the improvement observed post-treatment in 2021.
